COUNTIES (MD/PA) BALTIMORE/YORK  
M&D milestone no. 43 (46)  
MHT-HSI no. BA-1562

FIELD SHEET: MASON & DIXON LINE, MARYLAND-PENNSYLVANIA BOUNDARY MARKER SURVEY

MASON & DIXON WEST LINE: MILESTONE 43(46)

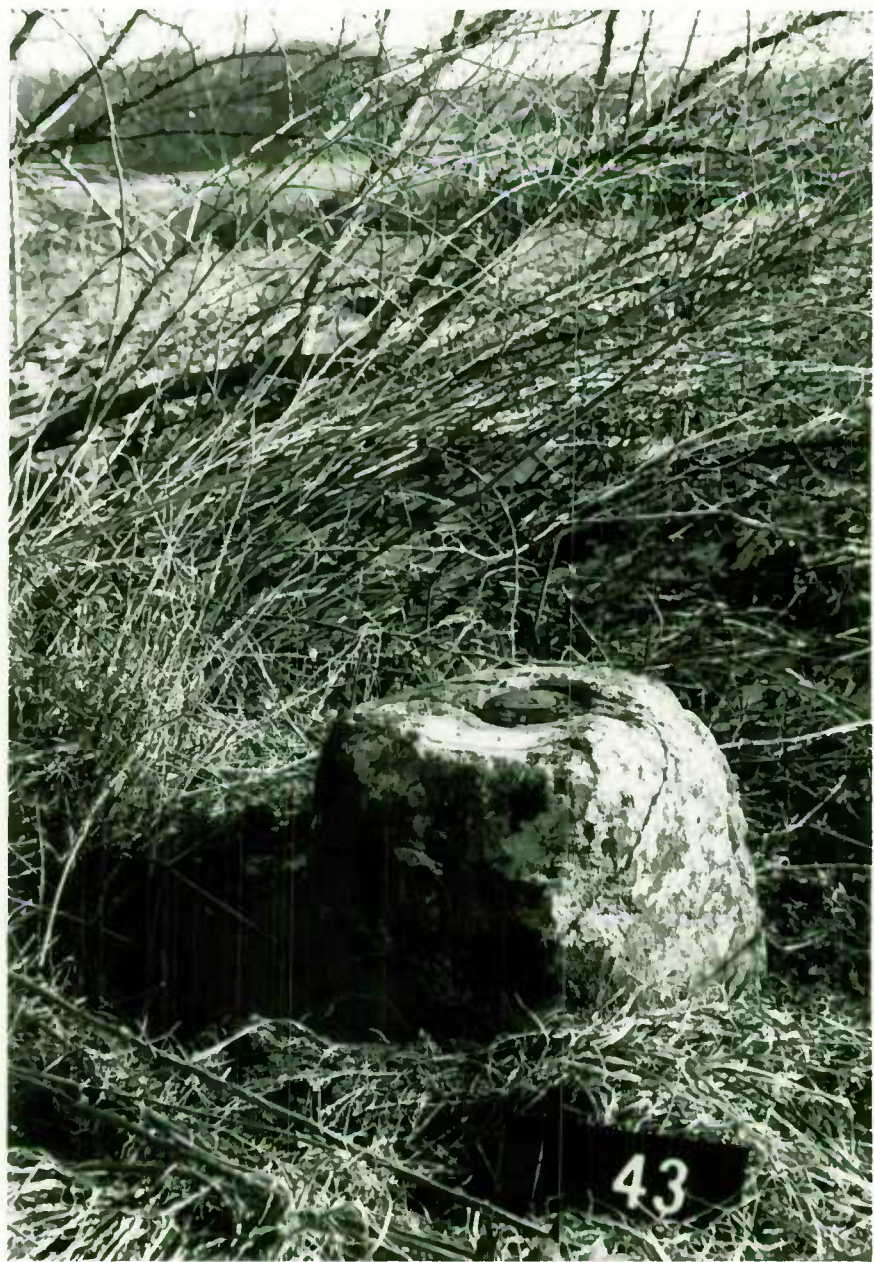
PHOTO: ALICE MARTIN 2/10/80 (1980-8-12)

43 (46). Replacement M&D original monument of 1767 from Washington Co. in place,  
in fair condition, firmly set but partially buried. Letters intact but circle  
panels, fluting & margins gone; all surfaces very weathered & chipped; (over)

large chips top corners. Stone endangered by farm machinery. Ref. Mark No. 2 out of ground.

HASON & DIXON WEST LINE: MILESTONE NO. 43 (NW CORNER)  
(PL) LOOKING SE ACROSS MRS. RIEFLE'S FIELDS

This stone has been chipped by farm machinery for many years, including recently. The property owners should be contacted and the stone marked with a metal witness post to help keep maintenance machinery safely away. The Reference Mark a short distance to the east should also be reset and protected in some way.

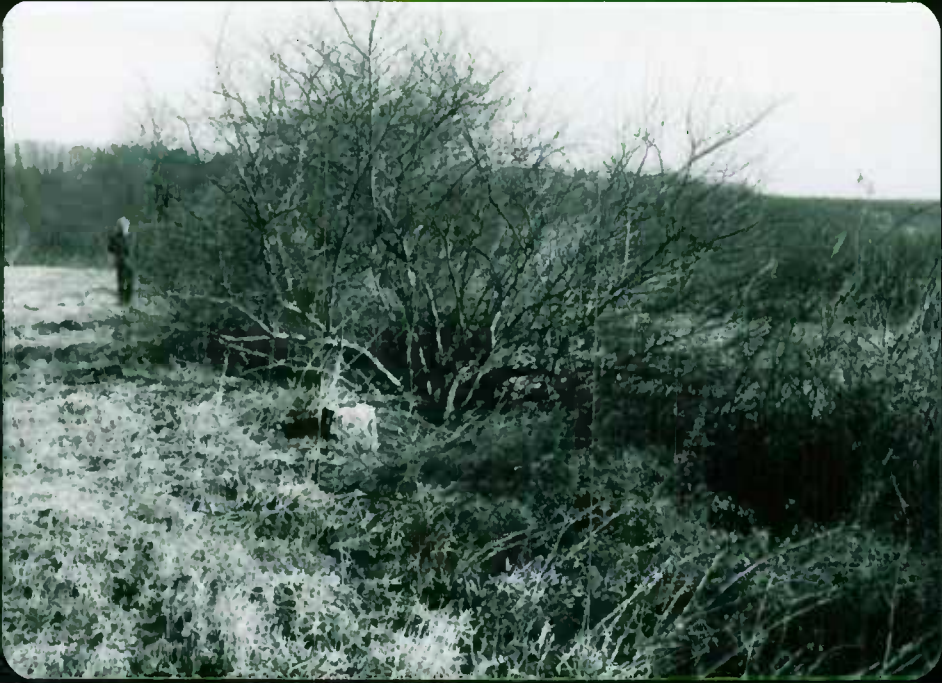
PHOTO: ALICE MARTIN 2/10/80 (1980.6.17)

MASON & DIXON WEST LINE: MILESTONE NO. 43  
LOOKING DUE EAST ALONG LINE TO BENCH  
MARK (STATION NO. 2) AT CLYDE'S FEET,  
LYING OUT OF GROUND ON ITS SIDE

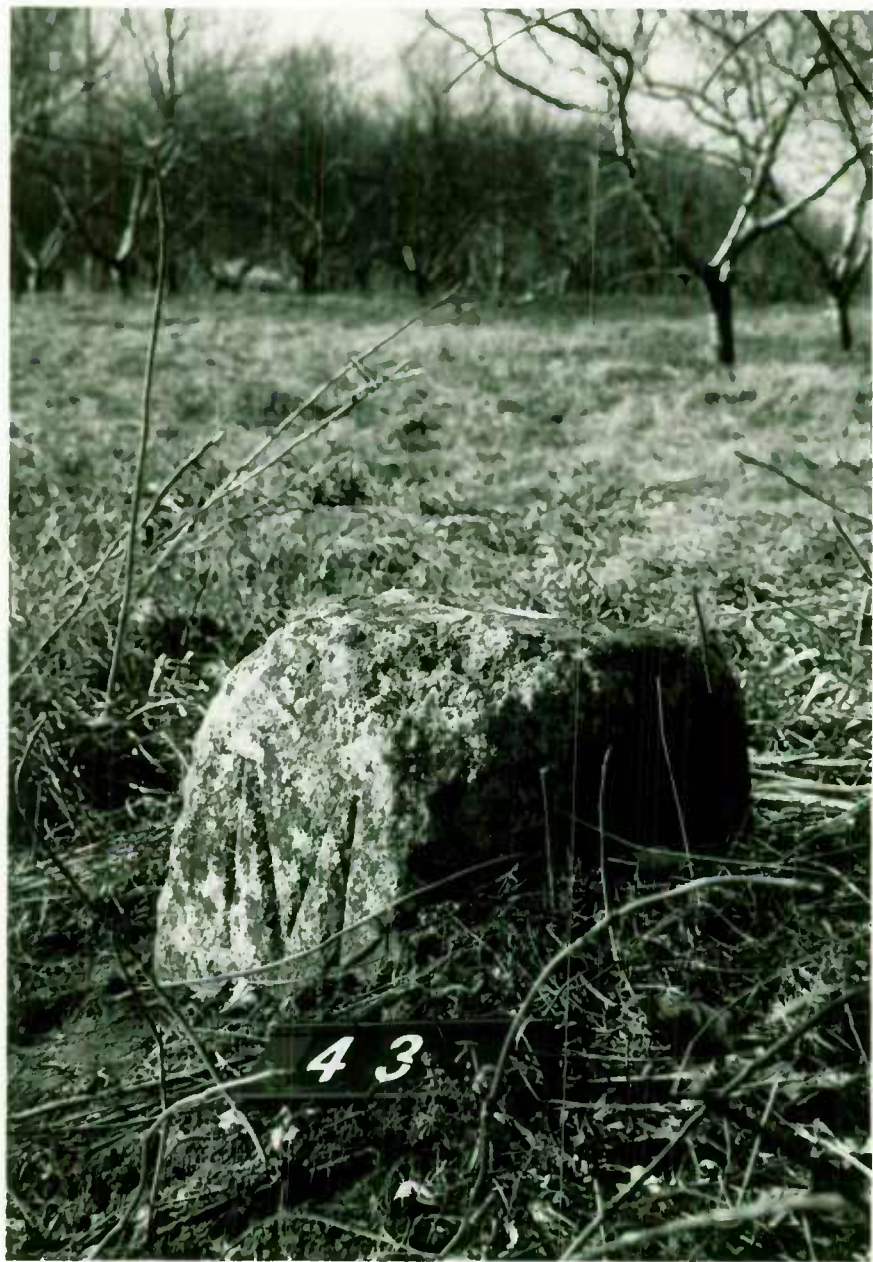
PHOTO: A. H. MASON 2/10/80 (1980-6-5)

MASON "DIXON WEST LINE" MILESTONE NO. 43 (SE CORNER)  
MI - } STARTING NEW THROUGH GREEN ORCHARD  
TOWARD KENNETH HAMEL HOUSE

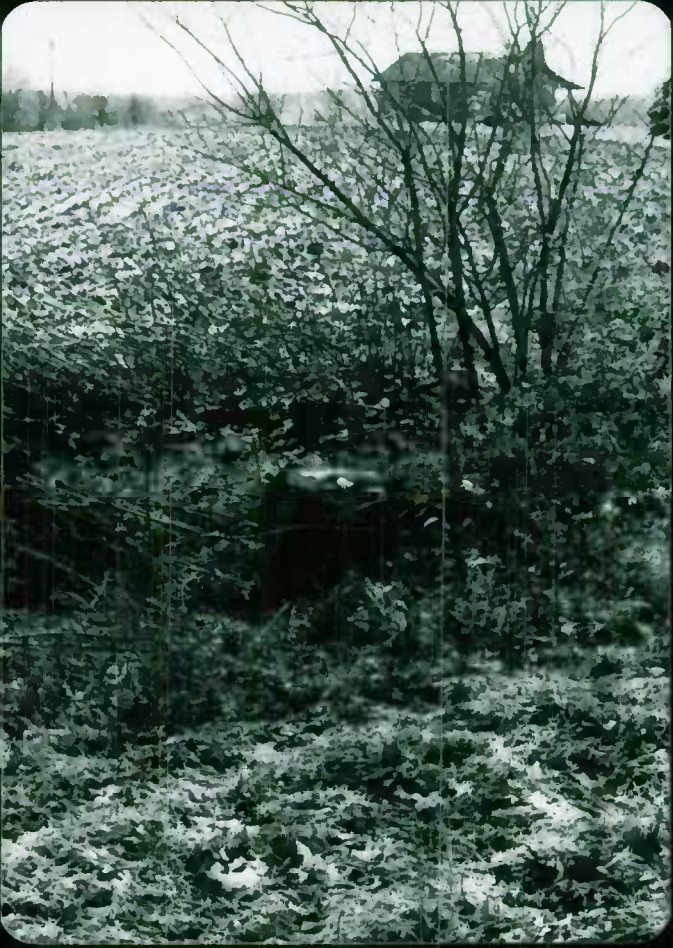
(1980.6.9)

BENCH MARK STATION NO. 2  
LOOKING SW TOWARD RIEFLE HOUSE

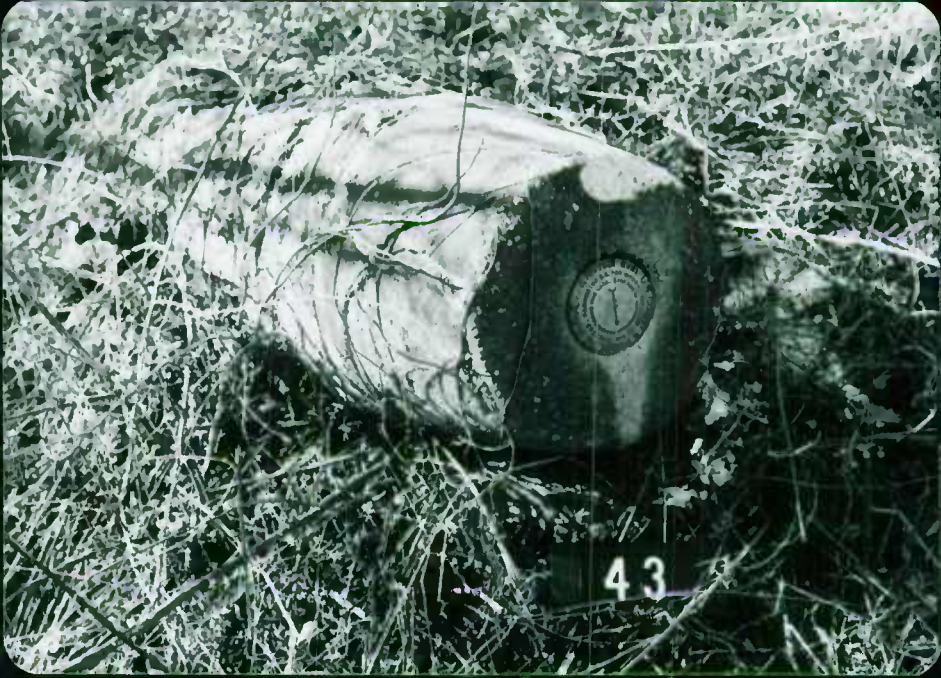
PHOTO: ALICE MARTIN 2/10/80 (180.6, 8)

HARVEY DIXON WEST LINE: (WITH) MILESTONE NO. 43  
BENCH MARK STATION NO. 2, OUT OF  
GROUND, ON ITS SIDE
